UNITED STATES  
NUCLEAR REGULATORY COMMISSION  
OFFICE OF INSPECTION AND ENFORCEMENT  
WASHINGTON, D.C. 20555

July 31, 1985

IE INFORMATION NOTICE NO. 85-65: CRACK GROWTH IN STEAM GENERATOR  
GIRTH WELDS

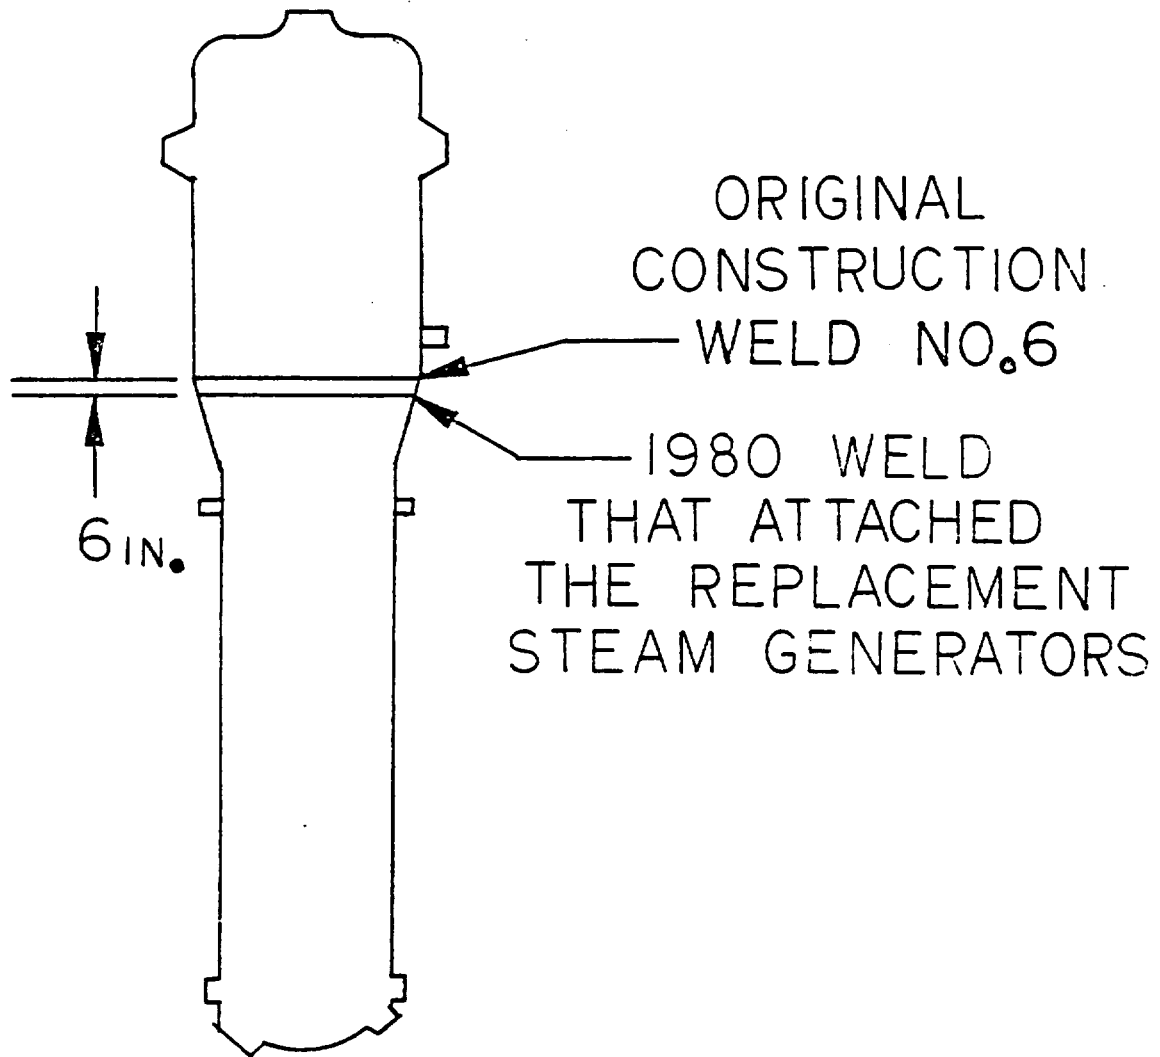
Sketch Showing Steam Generator A

In 1983 Surry Power Station Unit 2 performed ultrasonic examinations of the No. 6 welds. The original construction weld at Unit 2 is 6 inches above the weld that attached the lower portion of all three replacement steam generators in 1980 (see attached sketch). The examination showed widespread indications of discontinuities on the inside surface of this weld in the "A" steam generator. None of the indications seemed large enough to be rejected and it was

The cracks in generator A were in a narrow band at the upper edge of the weld and covered almost the entire inside diameter. The cracks were as deep as 1/2 inch and were covered by the surface oxide, which obscured detection by visual examination. Generators B and C had numerous, smaller, circumferential cracks in the same location. To complicate matters, there were 10 unacceptable subsurface indications in generator B, based on the requirements of ASME Section XI, IWB-3511. After a fracture and fatigue evaluation, these subsurface indications were accepted by ASME IWB-3600. The surface cracks in all three generators were removed by grinding; repair welding was not necessary.

Weld No. 6 was made on-site and had high residual stresses as a result of the low preheat and postweld heat treatment temperatures. The steel in the vicinity of the weld pitted when the secondary water contained high oxygen concentrations (higher than 25 ppb) and contaminants such as chlorides and copper ions. In addition to internal pressure, this portion of the steam generator has a change in cross-section and undergoes thermal cycling. Heat treatment of the nearby replacement weld in 1980 reduced the residual stresses, but could not undo any existing damage to the original construction weld. The cracks ran from pit to pit and grew to an unacceptable size in less than one inspection period.

At the next outage, the No. 6 welds in all three steam generators at Surry Unit 2 will be partially examined by magnetic particle testing. The subsurface indications in generator B also will be examined by ultrasonic methods. Slow growing corrosion cracks are irregular in length and depth. When the cracks are located in the fusion line between the weld and the base metal, evaluation is very difficult by ultrasonic methods alone. Magnetic particle testing is more sensitive than visual examination and supplements ultrasonic examinations where there is a possibility of surface defects. ASME Section XI specifies the maximum allowable planar indications and the methods of examination, but these methods may not be sufficient to identify indications and defects in all cases. Additional surface preparation, calibration notches, personnel training, and smaller ultrasonic probes may result in a better understanding of the ultrasonic indications.
